# **The Road Inventory of Minidoka National Wildlife Refuge Rupert, ID**

Prepared By:  
Federal Highway Administration  
Central Federal Lands Highway Division  
April 2013

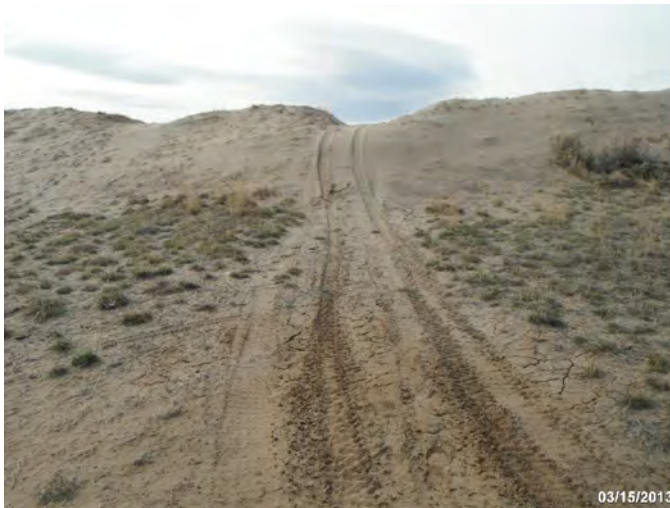
Photo: MINI\_C4\_0340 Route: 600-001-0.0  
Obstacle Sand Dunes- Road blocked by loose sand  
Prevents access to Route 108
